INDIVIDUAL BIOLOGICAL ASSESSMENT REPORT

Site Name/Facility: Chollas Creek Channel Emergency Maintenance

Master Program

Date: March 3, 2016

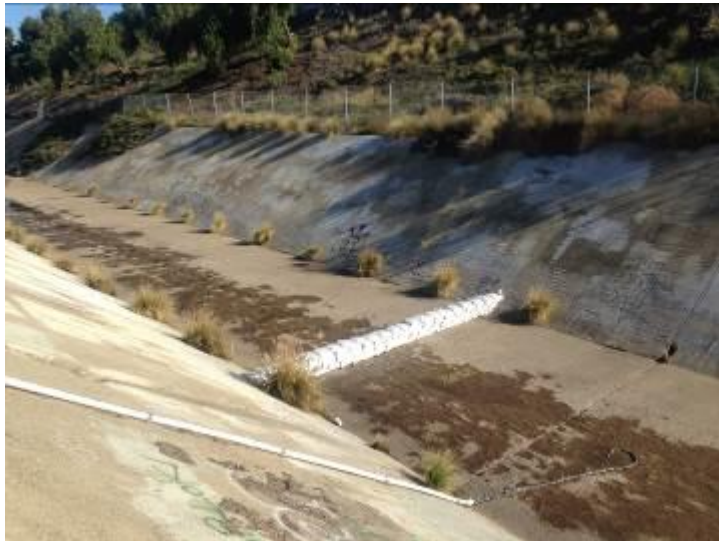
Photograph 1: Looking upstream from the northern Access/Staging area into the Chollas Creek channel at the sand bag berm adjacent to Durant St. within MMP Map 91; Figure 3a.

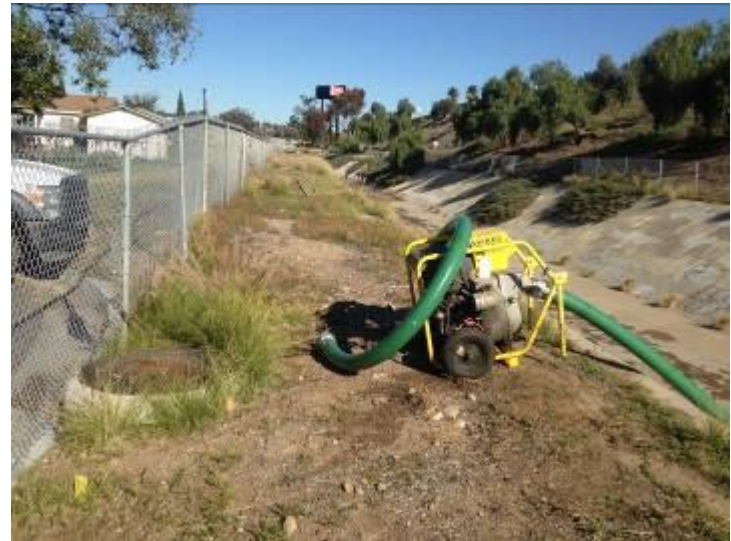
Photograph 2: Looking upstream adjacent to Durant St. at a bypass pump within MMP Map 91; Figure 3a.

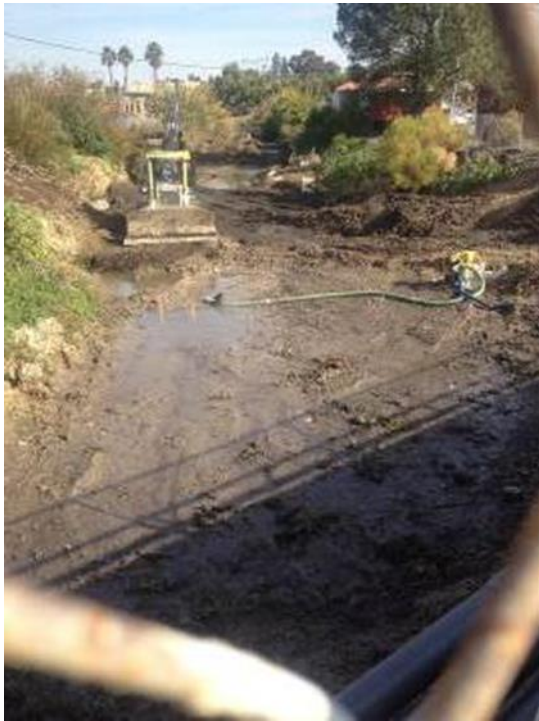
Photograph 4: Looking at work being conducted in the earthen section just north of the National Ave. bridge the south end of the maintenance area (MMP Map 93; Figure 3b).

In the second section, which is earthen and is located directly north of the National Ave. bridge (MMP Map 93; Figure 3b), the Loader, Dozer, and Trackhoe were also used to clear sediment and create a soil berm at the downstream end of the section. A Bobcat was also used to access areas near the bridge. Gas pumps were used to bypass water around the downstream berm and a filter bag was used at the hose outlet to prevent sediment and debris from being discharged downstream. Some vegetation within and adjacent to the channel were also removed using hand tools and chainsaws, including Arundo. The Arundo rhizomes were treated with Roundup to prevent future recruitment.

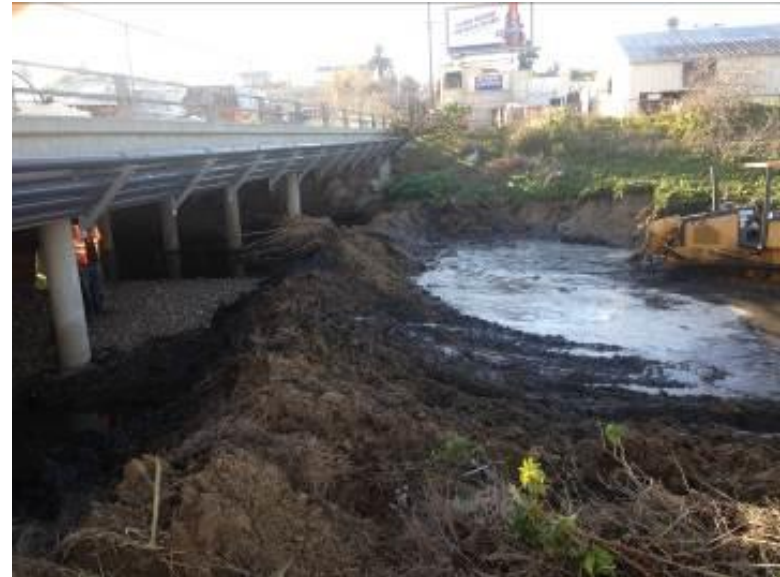
Photograph 5: Looking at the berm created on the north National Ave. during maintenance at the south end of the maintenance area.

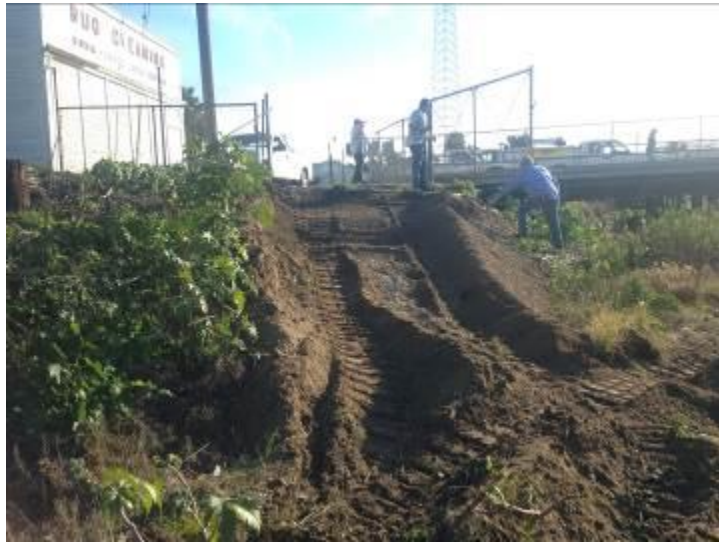
Photograph 6: Looking downstream at the southernmost Access/Staging area on the northeast end of the National Ave. bridge as crews prepare to access the maintenance area.

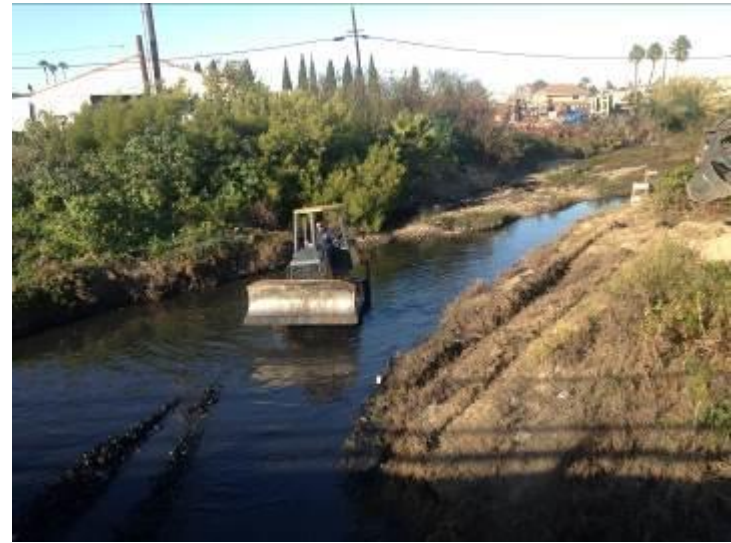
Photograph 7: Looking upstream from the National Ave. bridge from the south end of MMP Map 93; Figure 3b during maintenance work.

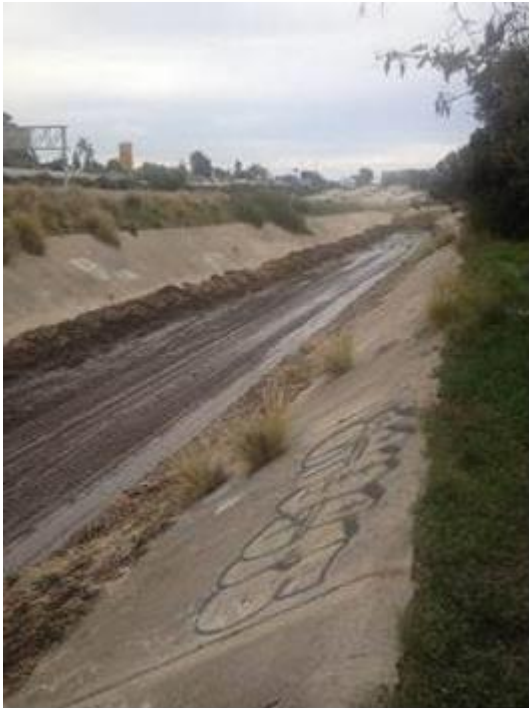
Photograph 8: Looking downstream during maintenance in the upstream concrete-lined section of the channel with MMP Map 91; Figure 3a.

As part of this emergency maintenance, all sediment and vegetation that had accumulated within each of the two channel sections was removed. In the first section located just east of South Gregory St. (MMP Map 91; Figure 3a), all materials were excavated from the channel segments utilizing the Loader, Dozer, Trackhoe, and dump trucks. Equipment accessed this concrete-lined channel section via the access point at the north end of MMP Map 91; Figure 3a. The Gradall was staged outside and above the channel within the disturbed Access/Staging area to the. A Pole Saw and chainsaws were also used to remove a large exotic tree on the southwestern end of this section.

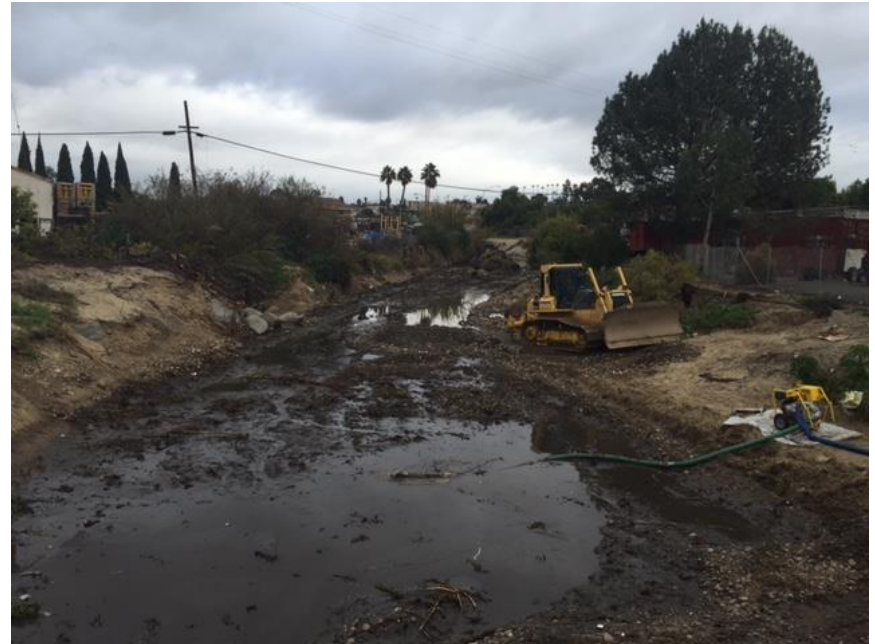
Photograph 9: Looking upstream from the National Ave. bridge from the south end of MMP Map 93; Figure 3b during maintenance work.

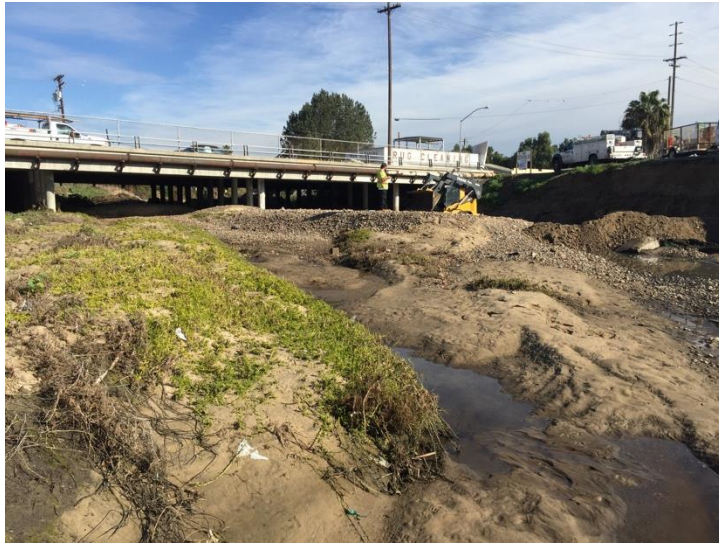
Photograph 10: Looking upstream portion of the channel south of the National Ave. bridge as crews construct the berm.

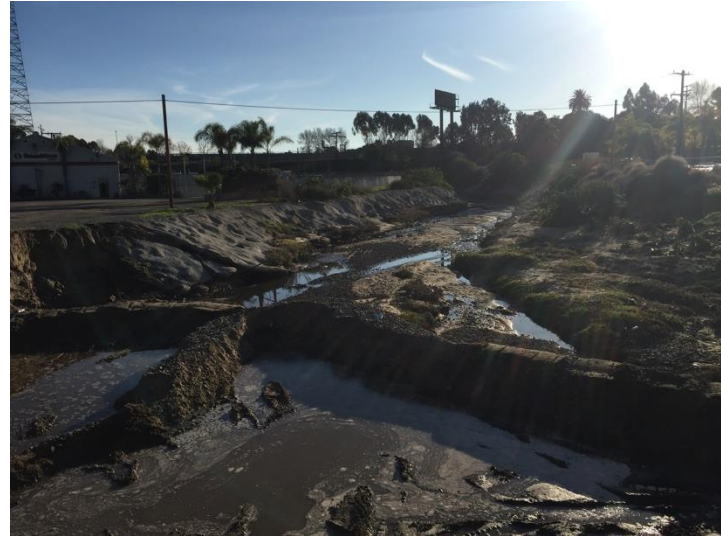
Photograph 11: Looking downstream from the National Ave. bridge from the south end of MMP Map 93; Figure 3b during maintenance work.

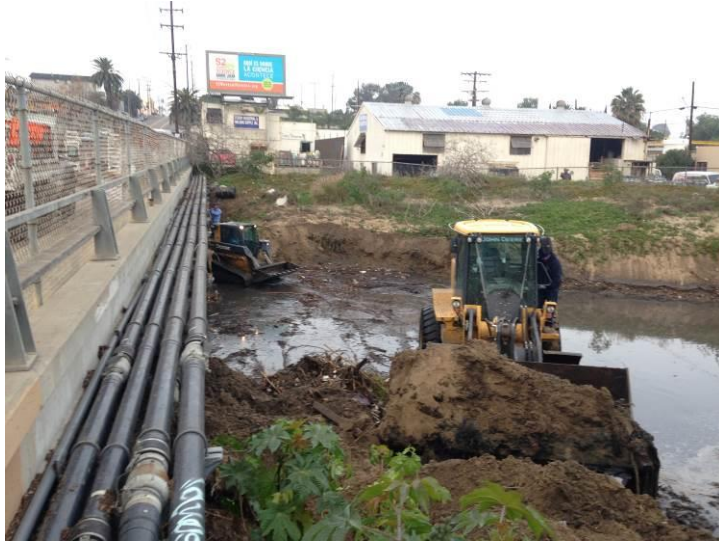
Photograph 12: Looking at the north side of the National Ave. bridge as crews remove the berm.

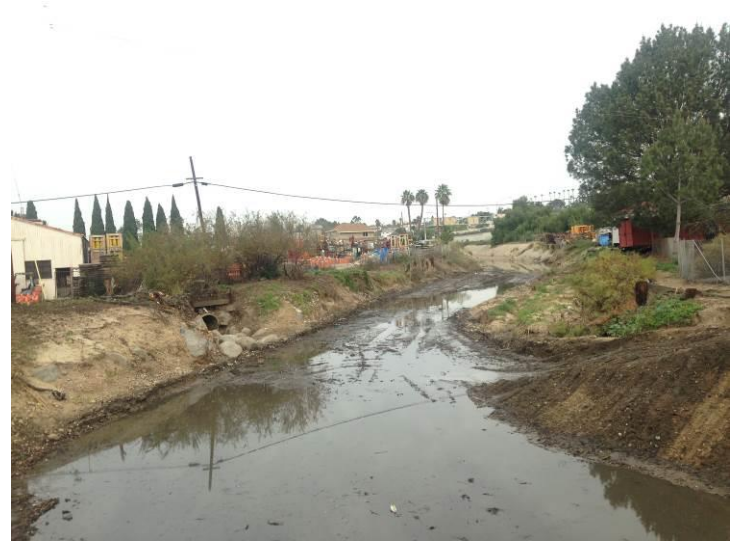
Photograph 7: Looking upstream from the National Ave. bridge following completion of maintenance.

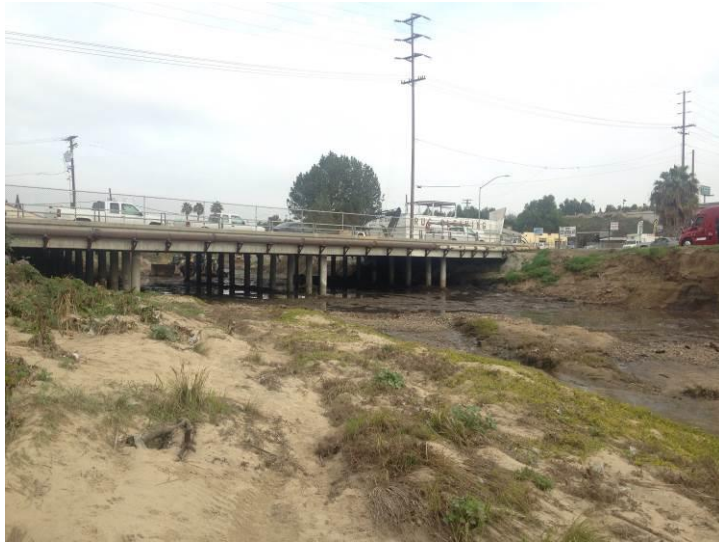
Photograph 6: Looking upstream towards the National Ave. bridge as following completion of maintenance.

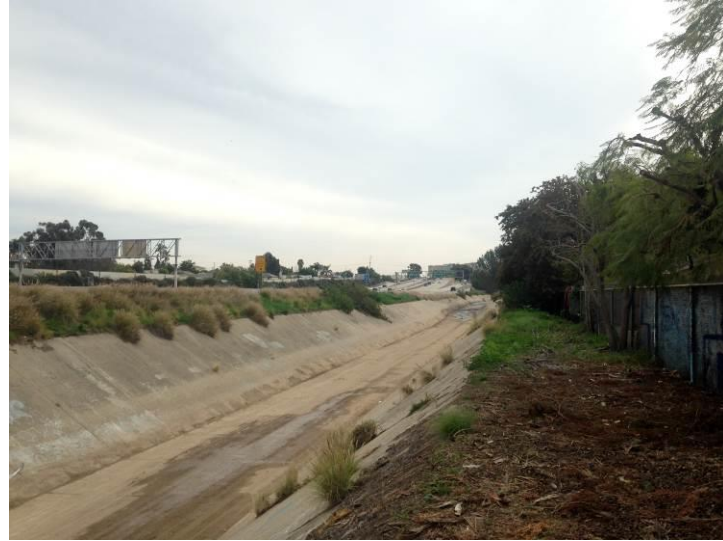
Photograph 7: Looking downstream at the concrete channel following completion of maintenance work.
